# FINAL REPORT FOR REMEDIATION OF LOCATIONS IN GRANITE CITY, MADISON, AND VENICE, ILLINOIS, ASSOCIATED WITH NL INDUSTRIES/TARACORP SUPERFUND SITE

## PRE-PLACED CONTRACT NO. DACW45-89-D-0506 DELIVERY ORDER NO. 0017

November 22, 1996 Project 16473

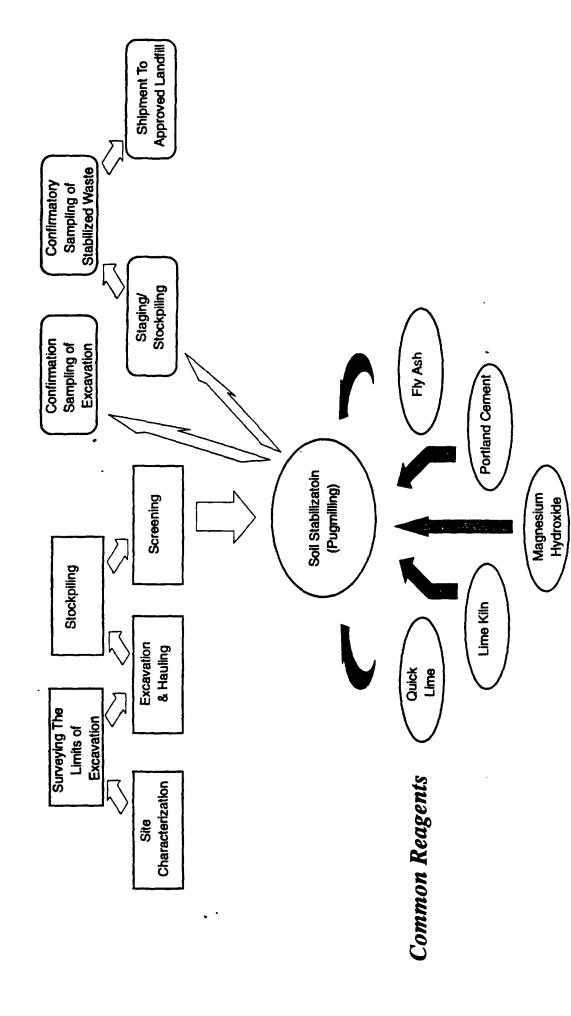
FIGURE 2.2

STABILIZATION METHODOLOGY

Stabilization, a chemical/physical process which immobilizes hazardous constituents, enabled the treated waste to meet or exceed federal and state standards prior to landfill disposal. The stabilized material met the applicable "treatment standards" (5 milligrams per liter [mg/l] for D008) specified in 40 CFR 268.41.

Due to the productivity of the pugmill, the hazardous soil had to be stored at the site until it could be processed. The soil was protected from the wind and rain by inert aqueous film-forming foam material (con-cover).

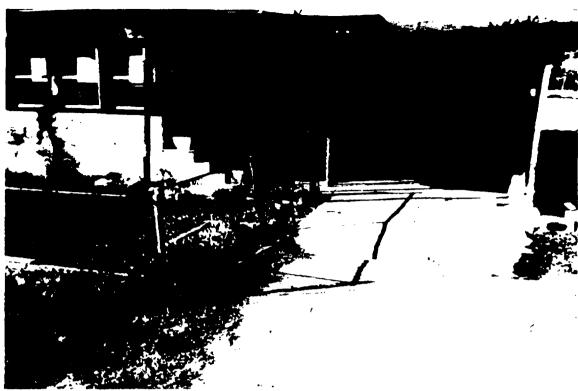
1. View of residential property prior to excavation.

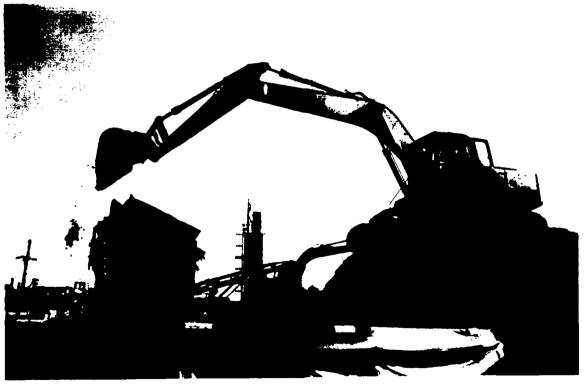
6. View of hazardous soil being fed into power screen.

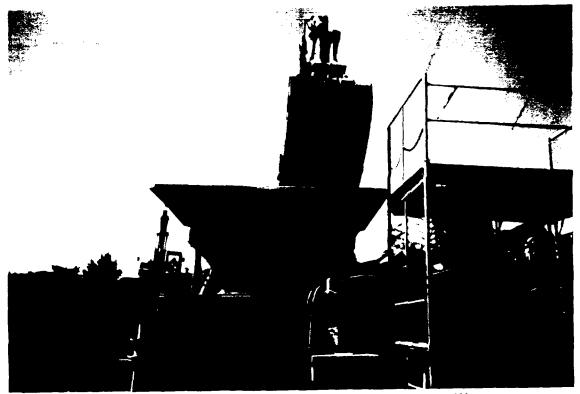
7. View of screened hazardous soil being fed into pugmill.

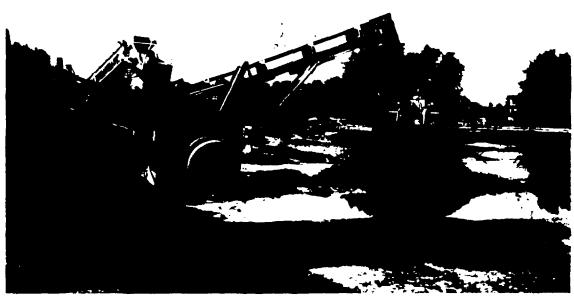
8. View of treated soil to be stockpiled into 100-ton piles.

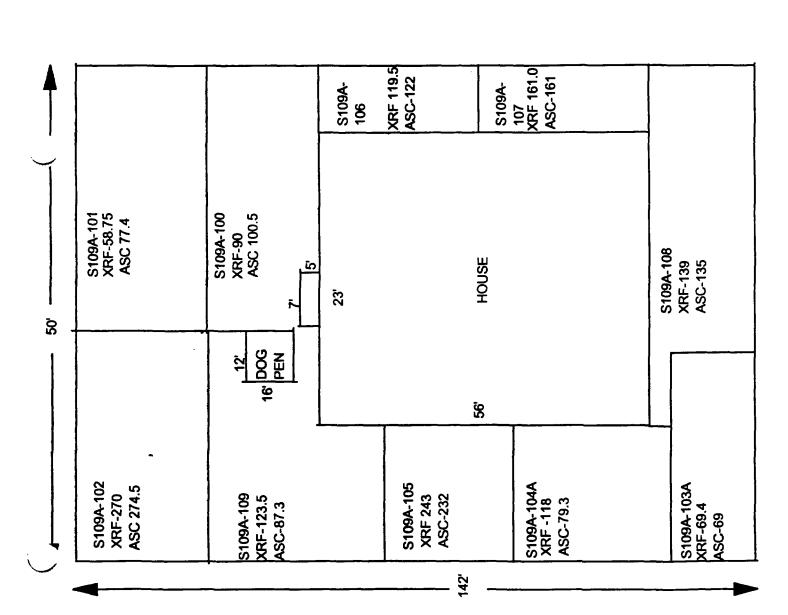
109 ALLEN TOTAL DIMESIONS 125 X 50 3/16/95

\* RESULTS IN PPM
